Rehabilitating the Brawner Farm

Manassas National Battlefield Park

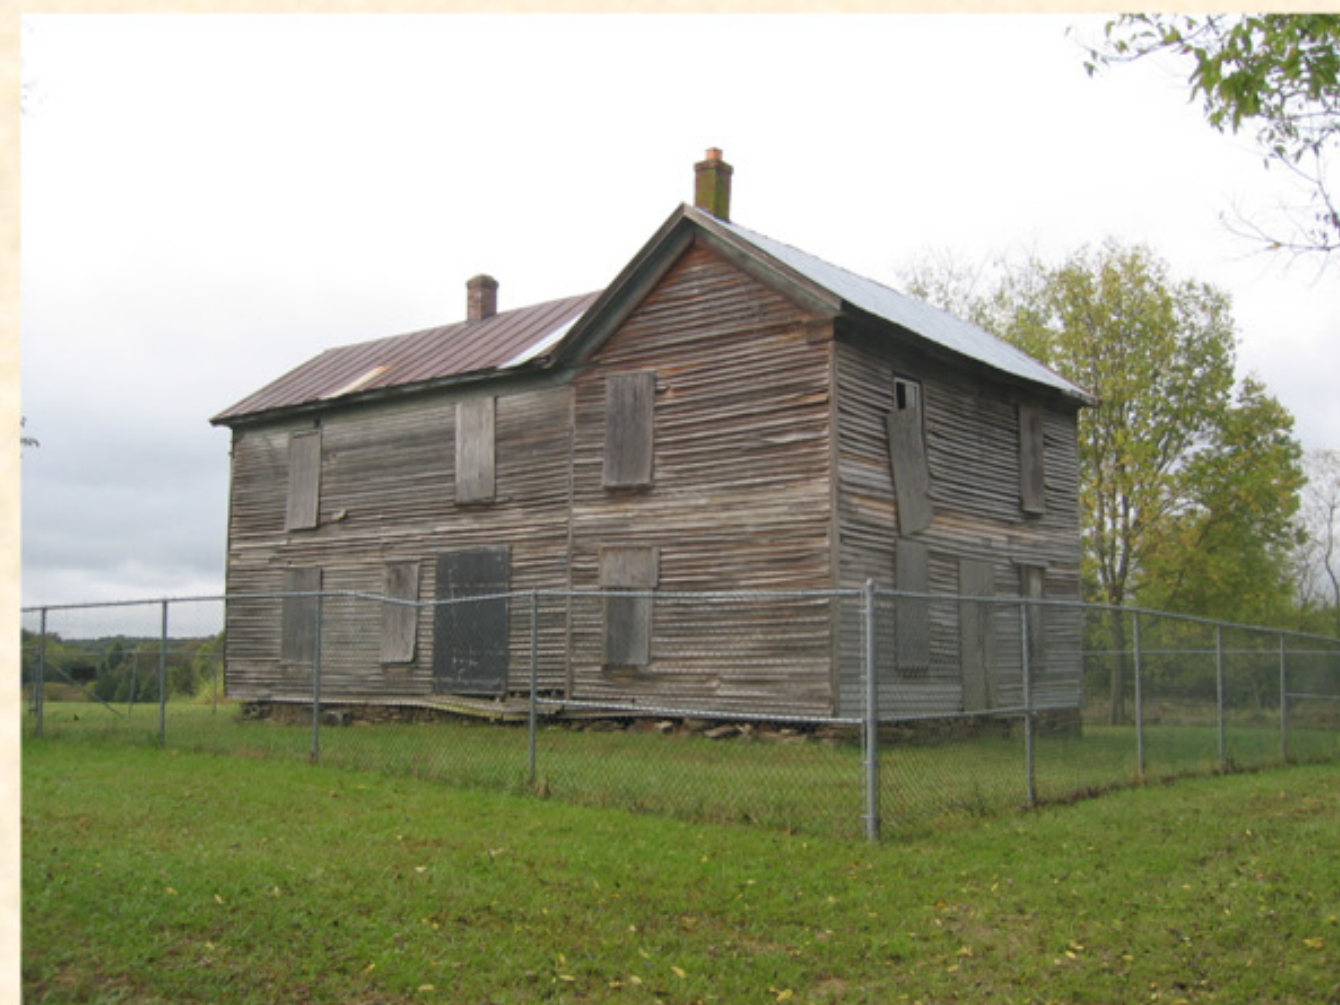
The post-Civil War house at Brawner Farm, prior to NPS rehabilitation. The view is from the northeast. The right portion (or north block) of the house bears signs of antebellum construction and may have been moved to this site after the Civil War. It partially overlays the archeological remains of the pre-Civil War house. The left (south block) portion of the house was added c. 1905.

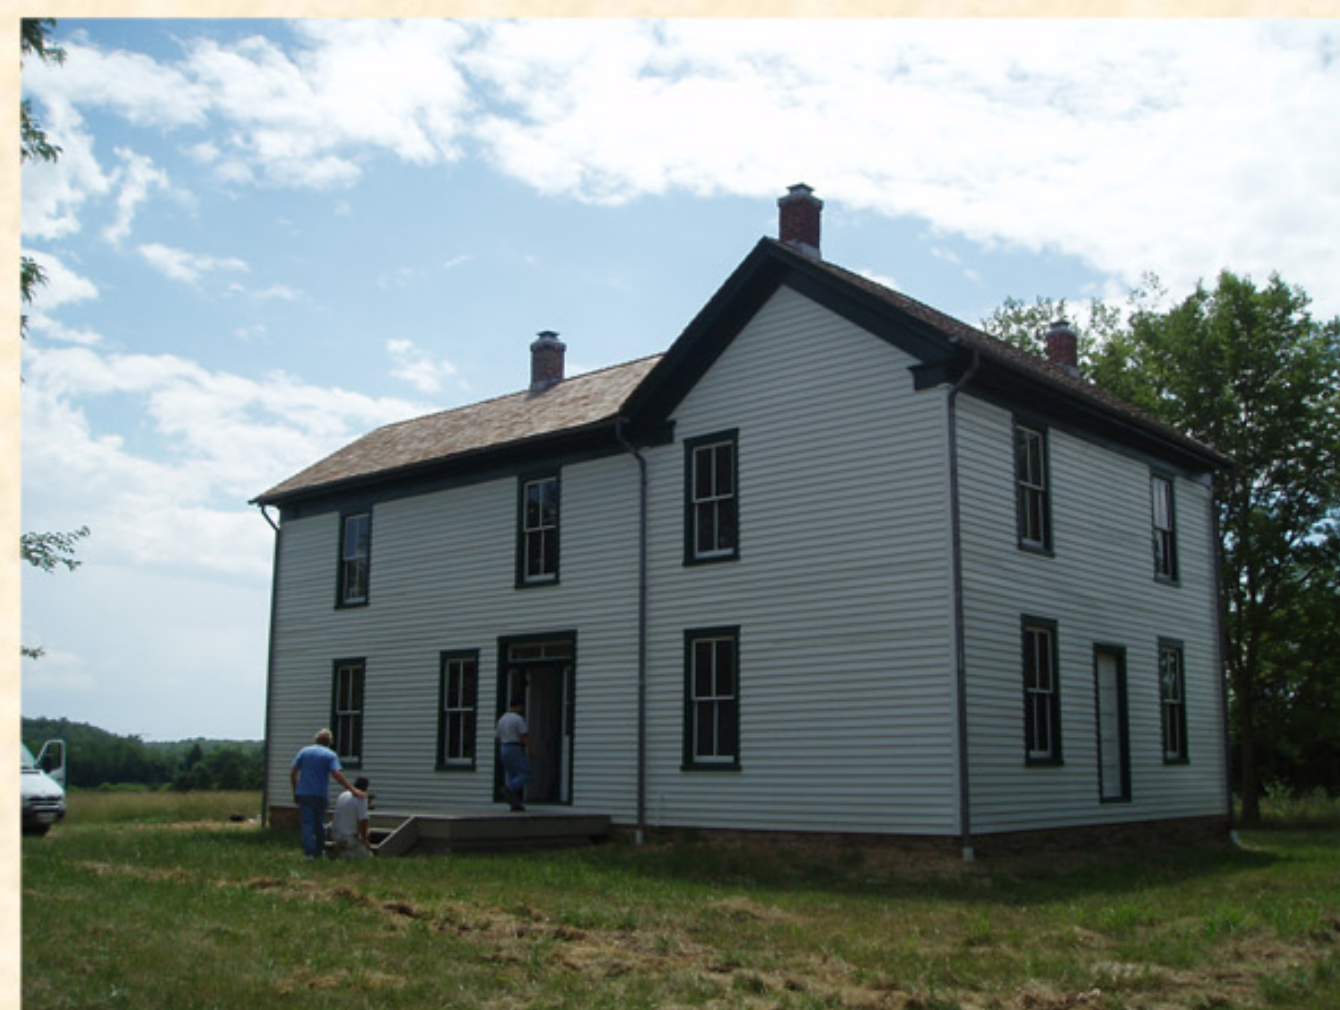
The house following rehabilitation. The view is from the northeast. Note the new wood shingle roof and siding, as well as the rebuilt foundation. The platform at the east entrance conceals a vault containing the building's fire suppression equipment.

With the availability of line item construction funding in FY 2005, the National Park Service initiated a contract to implement the rehabilitation project. The contracted work included rebuilding the stone foundation, as well as repairs to the sill and the building's framing and flooring systems. The contractor reused original flooring, windows, and trim where possible and replaced missing or badly damaged features, including some doors and nearly all of the plaster surfaces. The contractor also installed new exterior siding and a wood shingle roof. To support the building's adaptive use as an interpretive facility for Second Manassas, the contractor also installed electrical service, as well as an alarm and fire suppression system to protect the building. A new access road, parking lot, and pedestrian path were also constructed to improve site access for park visitors. With the substantial completion of the project in FY 2007, the rehabilitated house at Brawner Farm will be available to provide visitors a place to obtain an orientation to the battlefield and gain a greater understanding of the Second Manassas battle story.

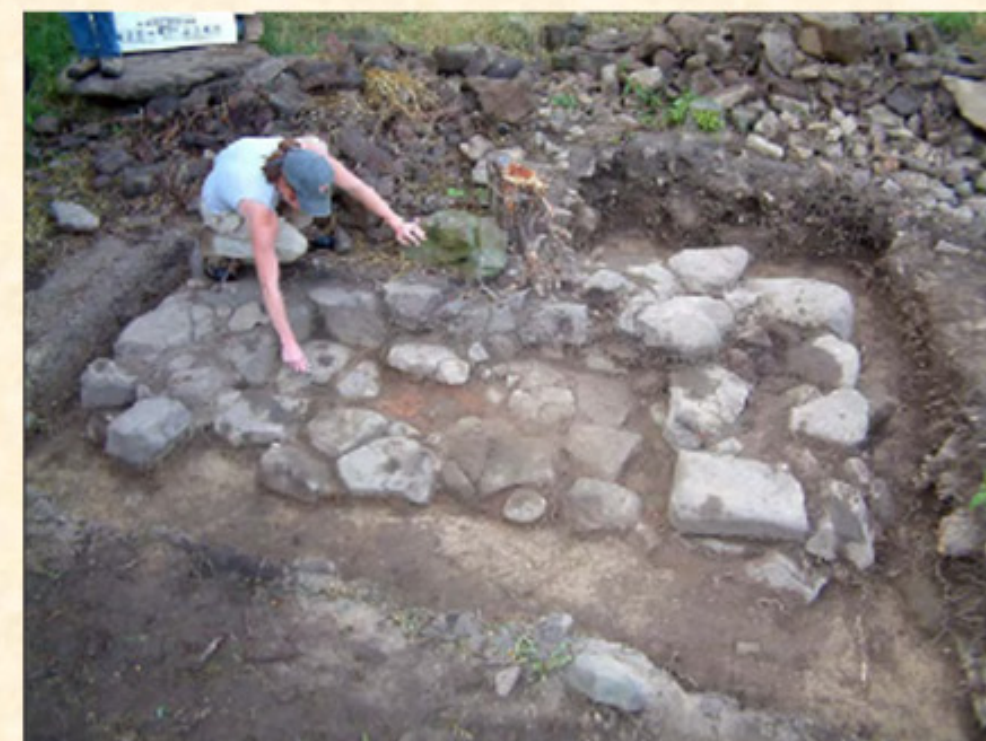
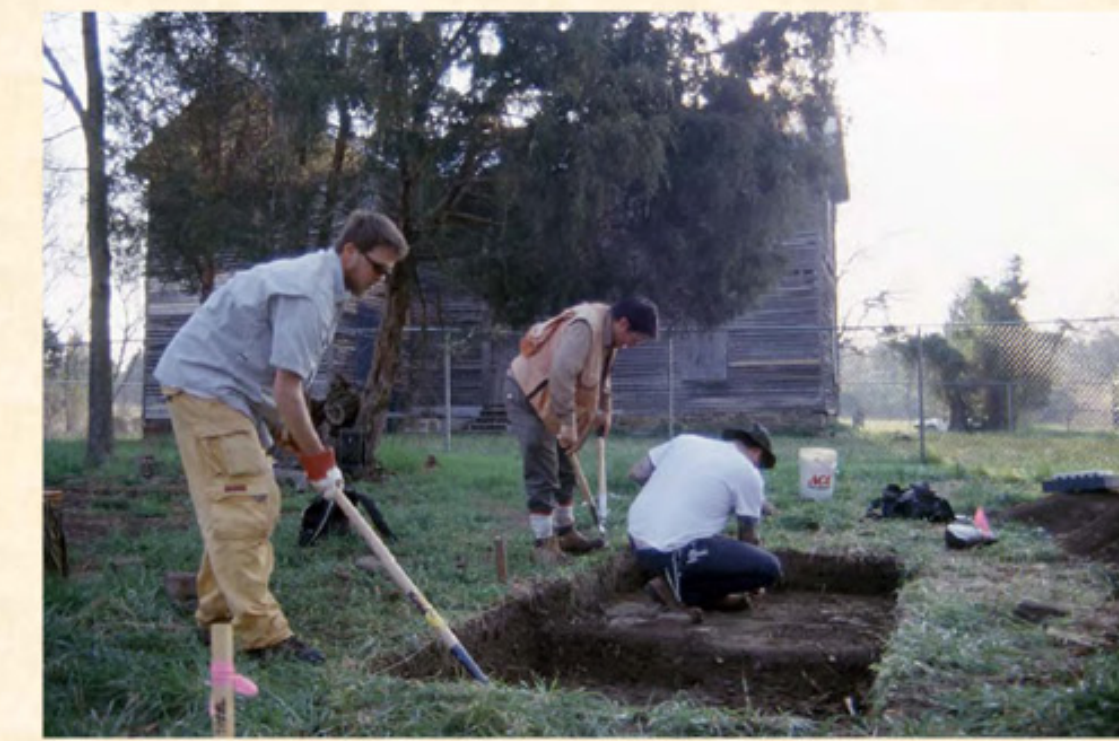
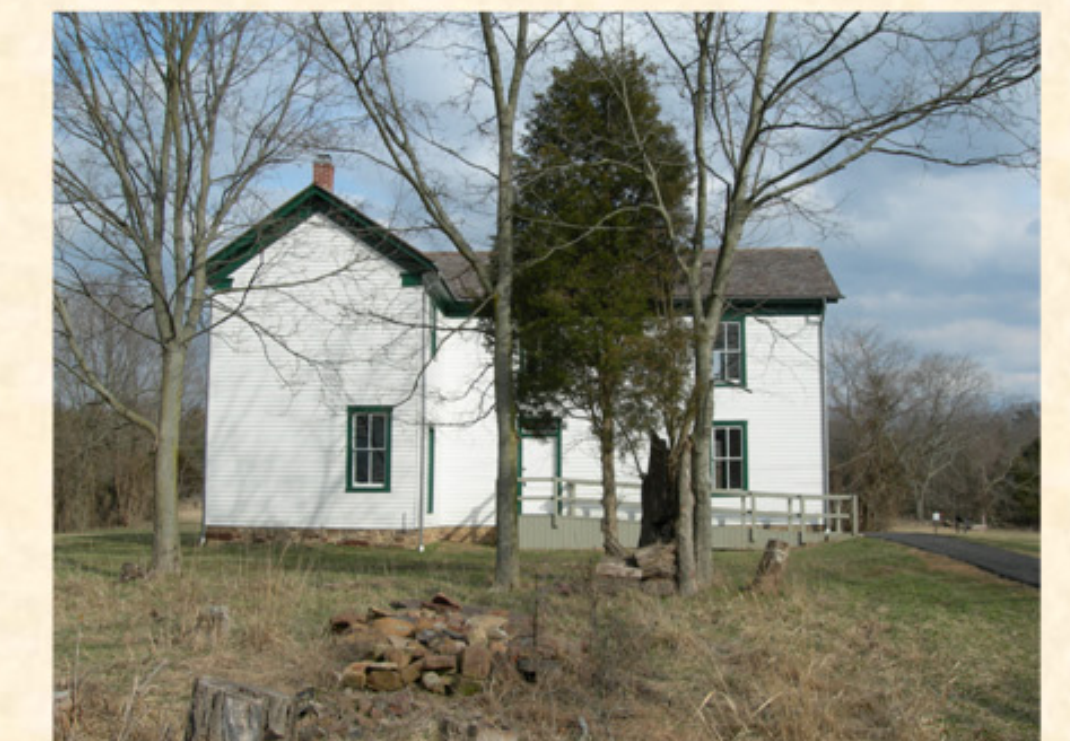
From left to right, excavation of chimney base of kitchen/slave quarter (Feature 25) in the west yard; investigation of area around the kitchen/slave quarter; the west yard and farmhouse at the conclusion of the project. The paved pedestrian path on the far right of the photo was aligned to avoid impacting the archeological resources of the west yard area.

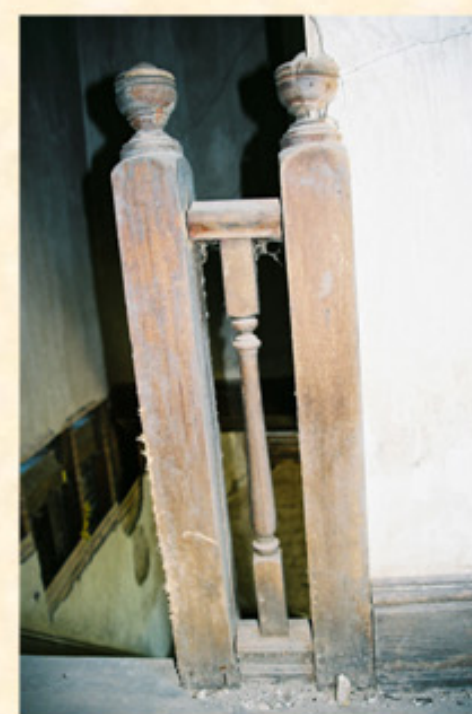
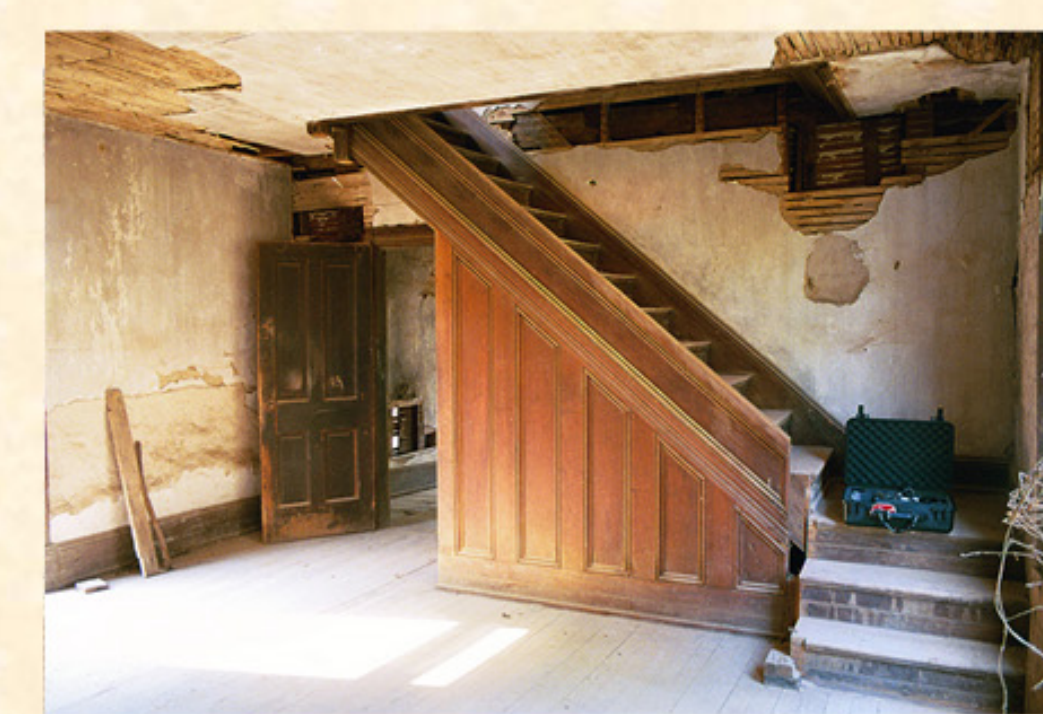
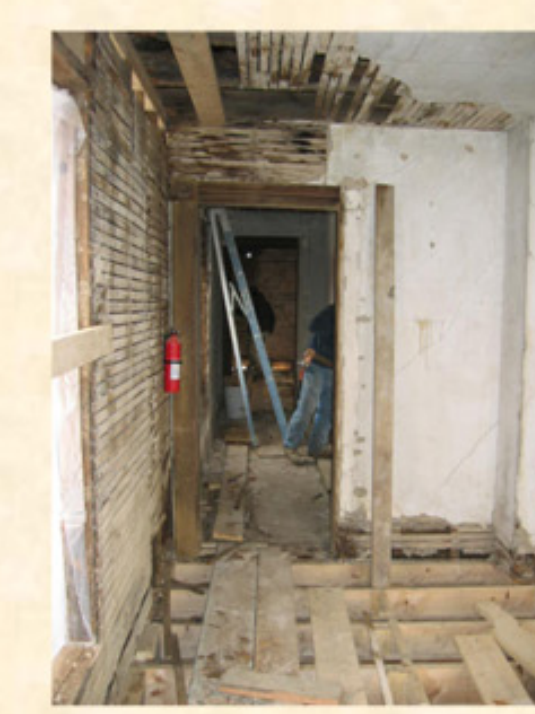
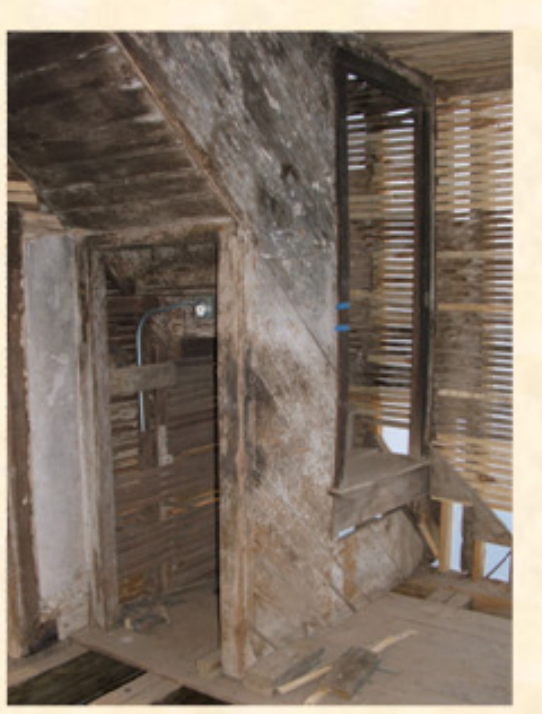
From left to right, interior views of farmhouse prior to rehabilitation: surviving remnant of stair rail on second floor; view of entry hall (Room 103), showing main stair with missing banister and newel post and damaged plaster surfaces; view of south bedroom (Room 205) and hall (Room 203) on second floor, showing damaged or missing plaster, flooring, and door trim; view of enclosed stair in kitchen (Room 102) on first floor.

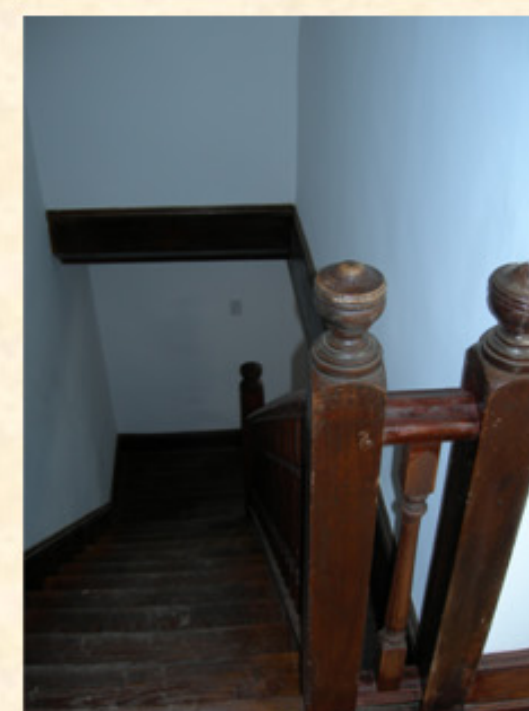
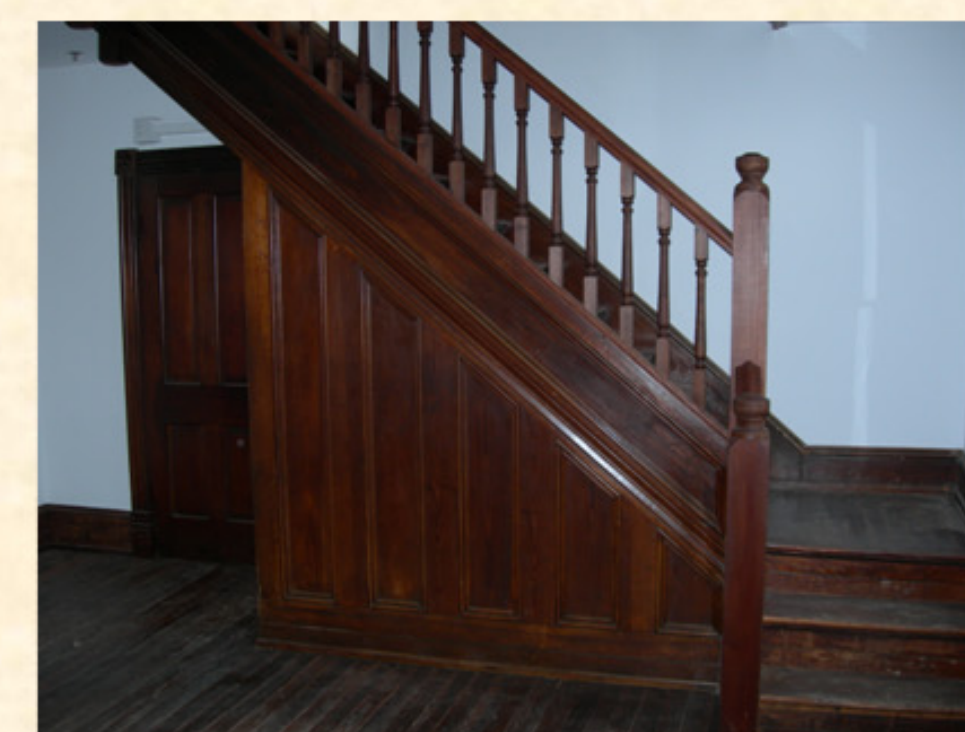
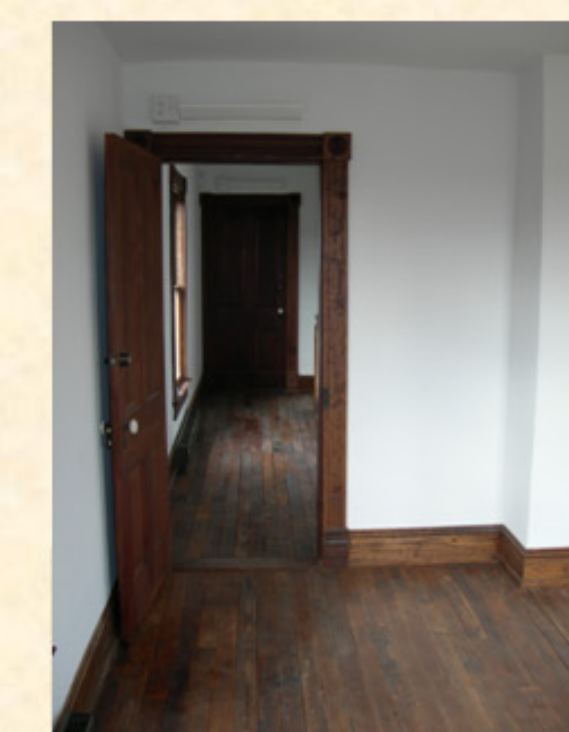
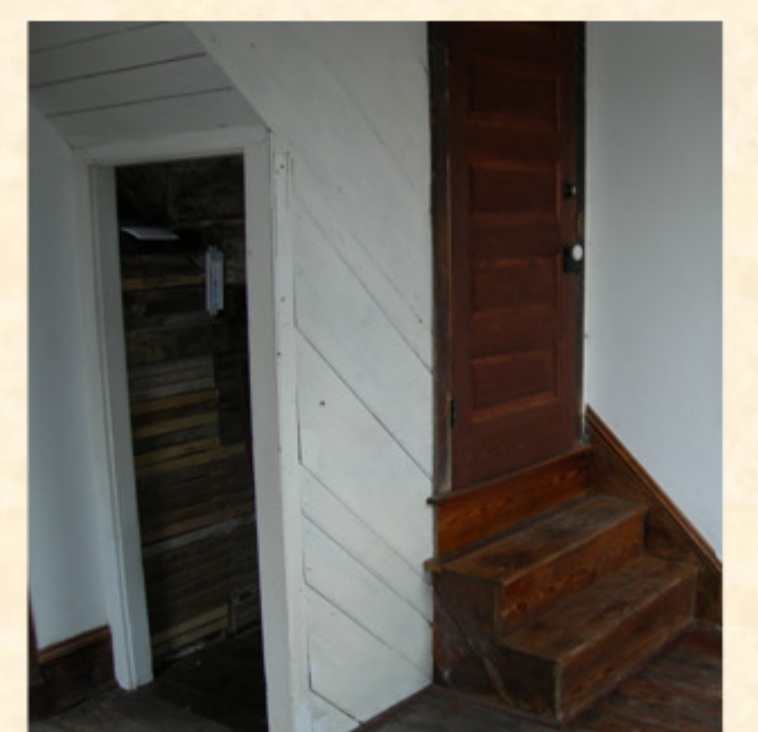
From left to right, interior views of farmhouse following rehabilitation: view of surviving stair rail remnant with reproduction banister; view of entry hall (Room 103), with new banister and plaster surfaces; view of south bedroom (Room 205) and hall (Room 203) on second floor, showing repairs to plaster, flooring, and trim; view of enclosed stair in kitchen (Room 102) after repairs.
